# Manhole Inspection Summary

Manhole # S19MM1008MH

Insp Date: **6/28/07 10:21 AM**

**Location** Address: **2001 COLD SRPING LN**

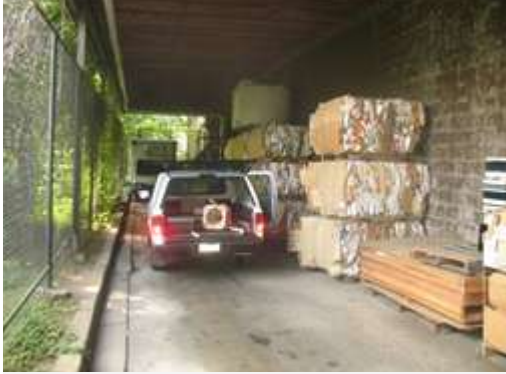
Location View

Comments **The MH is located on the side of a building in a driveway.**

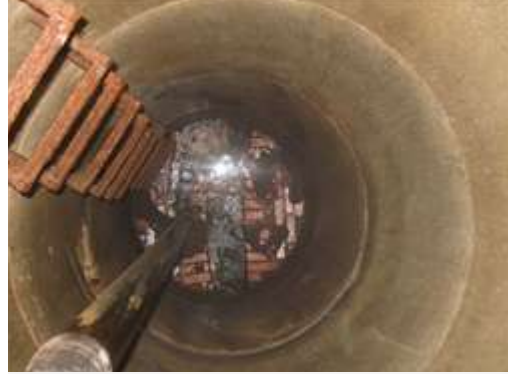
Top View

Bench and Channel debris.

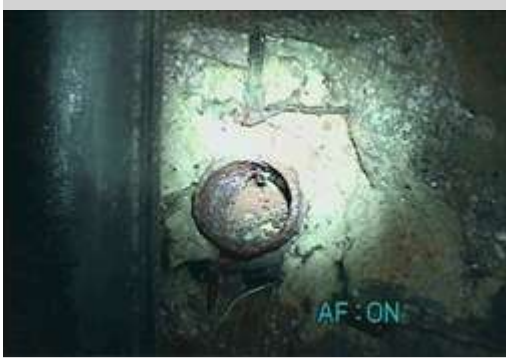
Defect

PIC OF OLD DROP CONN. PIC ALSO SHOWS A VOID IN CORBEL WALL EXPOSING REBAR

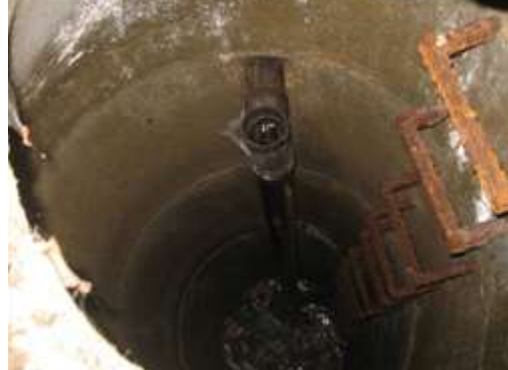
Defect

PIC OF DEFECTIVE STEPS

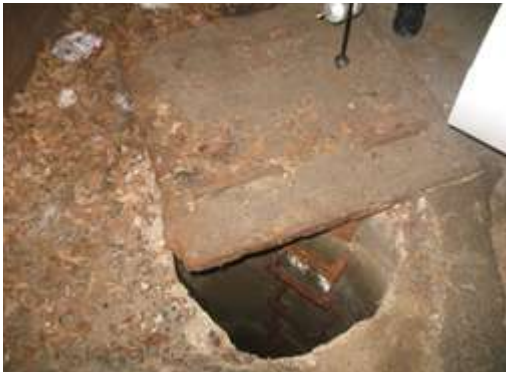
Defect

THERE IS COVER FOR THIS MH. JUS A METAL PLATE

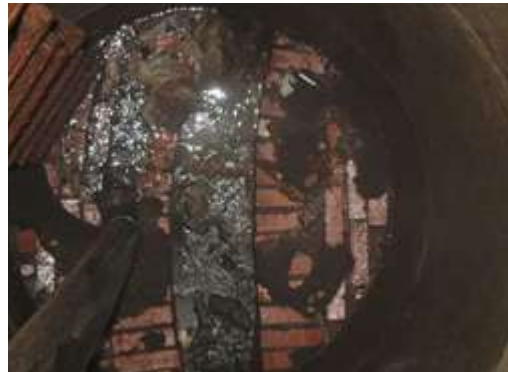
Defect

CHANNEL FULL OF DEBRIS AND SLUDGE

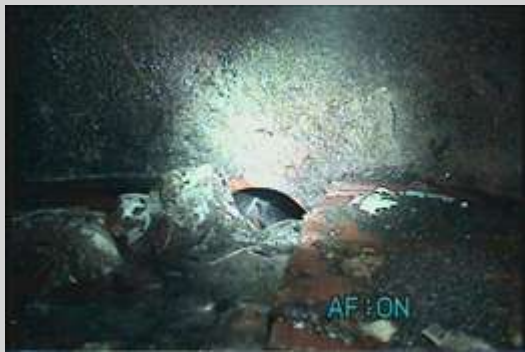
### 10 in. Circular Gravity Sewer Pipe Out @ 12 O'Clock

Invert Depth: **11.71** (ft.) Flow Characteristics: **Slow**

Infiltration: **Evidence** Pipe Seal Cond: **Unknown**

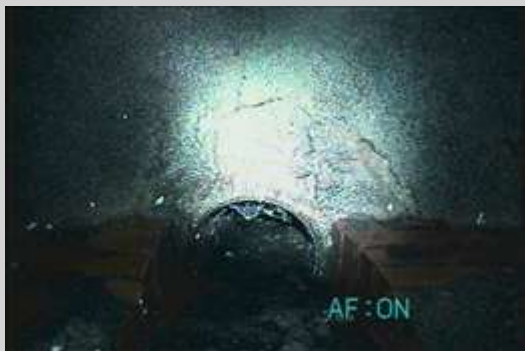
### 8 in. Circular Gravity Sewer Pipe In @ 6 O'Clock

Invert Depth: **13.55** (ft.) Flow Characteristics: **Slow**

Infiltration: **Evidence** Pipe Seal Cond: **Unknown**
